## **Camshaft Endfloat Mod GS550 – GS1100 (2 valve engines)**

**Ian Grant (49er)    June 2007 (v 2)**

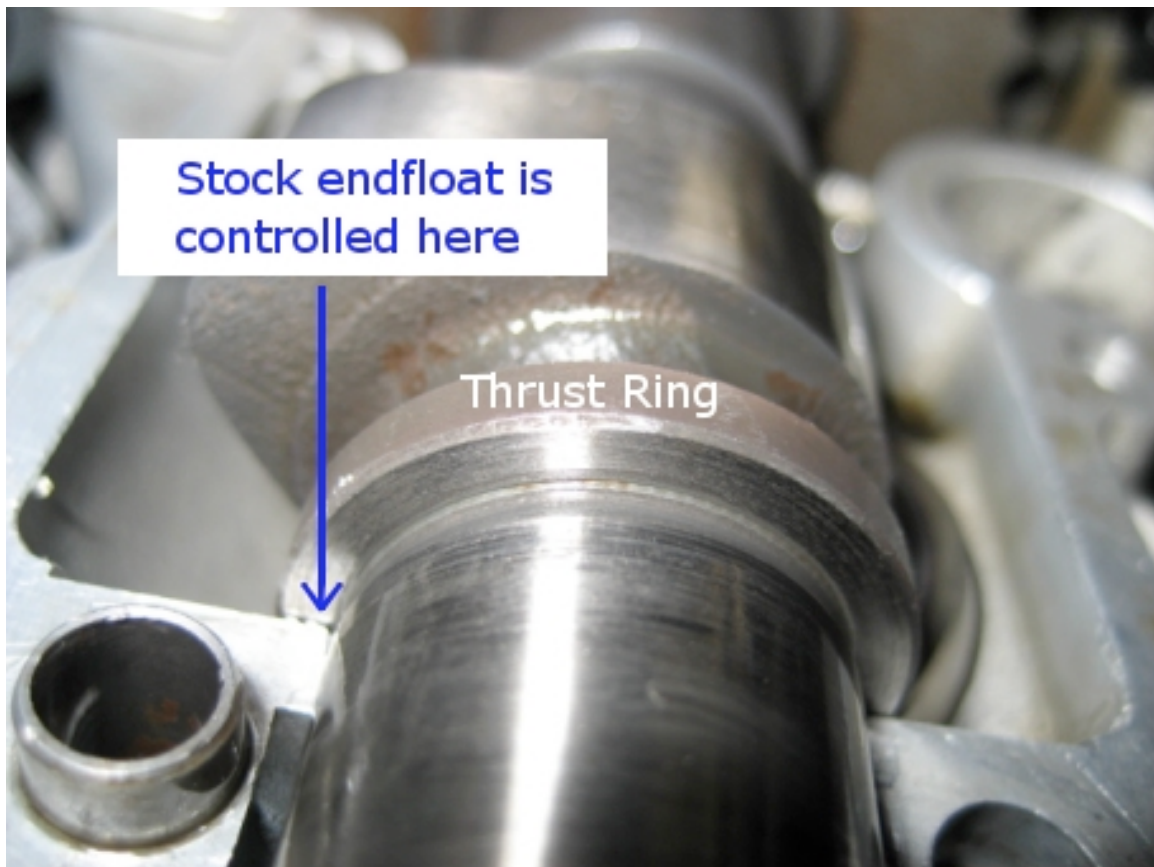
The endfloat is controlled by the bearing end faces making contact with the cam thrust rings adjacent to the bearing surface on the head only. The cap ends are about 1 to 1.5mm short of the thrust rings. Each camshaft is mounted in two bearings, the thrust in each direction is controlled by one bearing each.

I measured the gap between the thrust rings and the bearing thrust faces. The inlet cam thrust clearance was 0.005 in, the exhaust was 0.006 in. I calculated that the stock clearances should have been 0.0015 in for each camshaft.

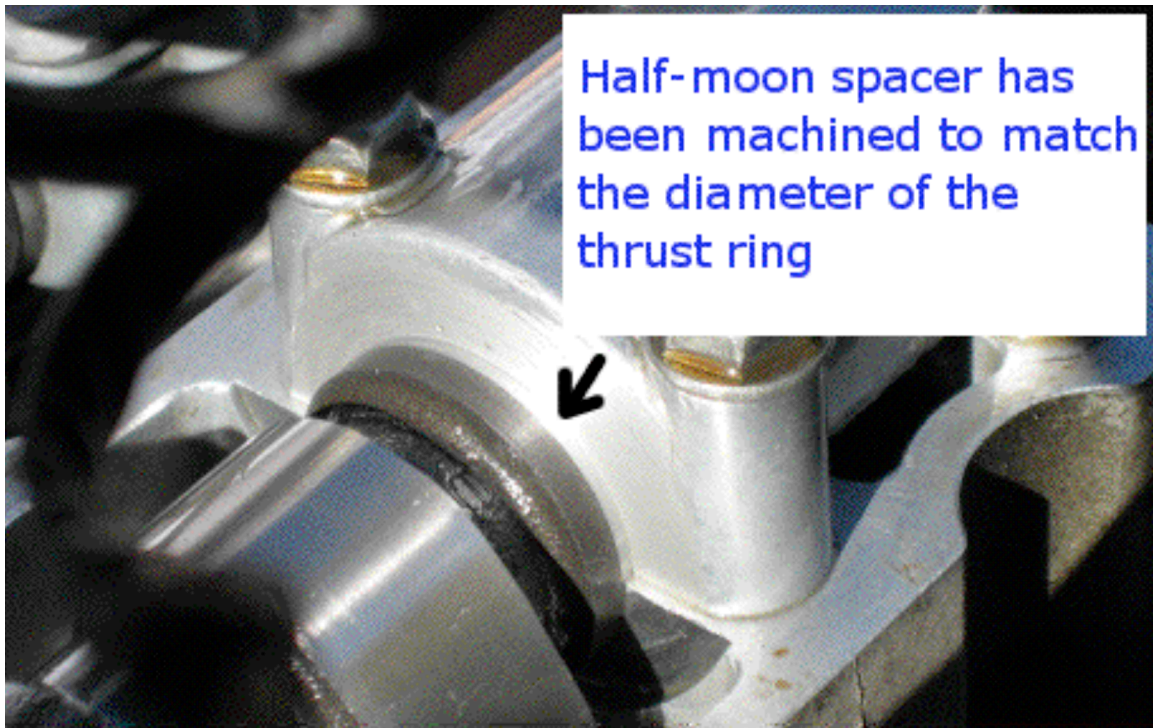
*This photo shows a half-moon spacer controlling the endfloat through the bearing cap.*

Change the thrust control from the bearing faces on the head to the adjacent area on the caps. Would the caps be sturdy enough to take the load? I thought so, as each cap is diagonally dowelled and secured to the head by four 6mm high tensile bolts.

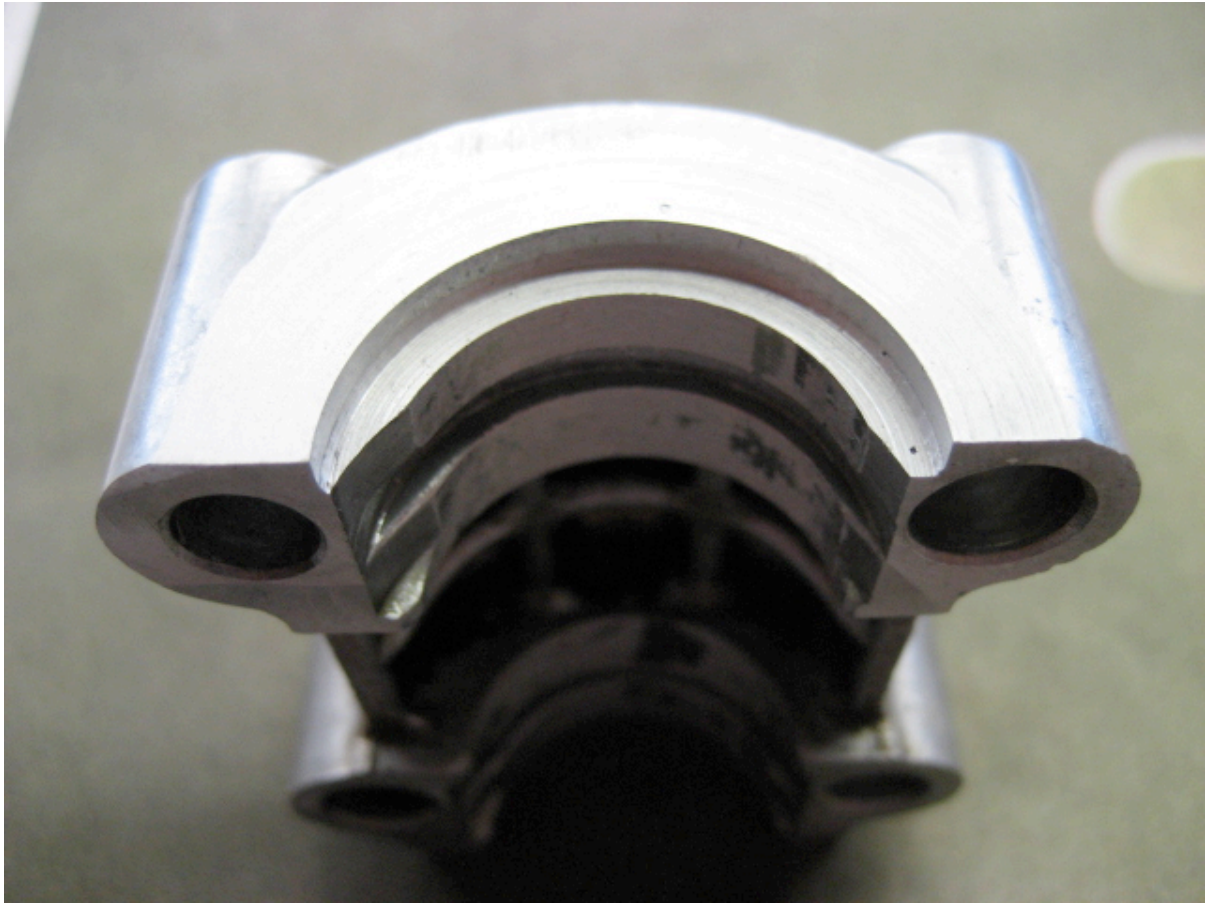
*This photo shows a bearing cap after the spacer recess has been machined. Note the slight radius left in the corner of the recess. Thrust spacers are machined with a chamfer to accommodate this fit-up.*

5. Check for runout.
6. Lightly face off the cap ends removing the casting irregularities.
7. Fit up a boring bar and machine a 27mm diameter x 3mm deep recess into each set of mated caps.
