## **Camshaft Endfloat Mod GS550 – GS1100 (2 valve engines)**

**Ian Grant (49er)    June 2007 (v 2)**

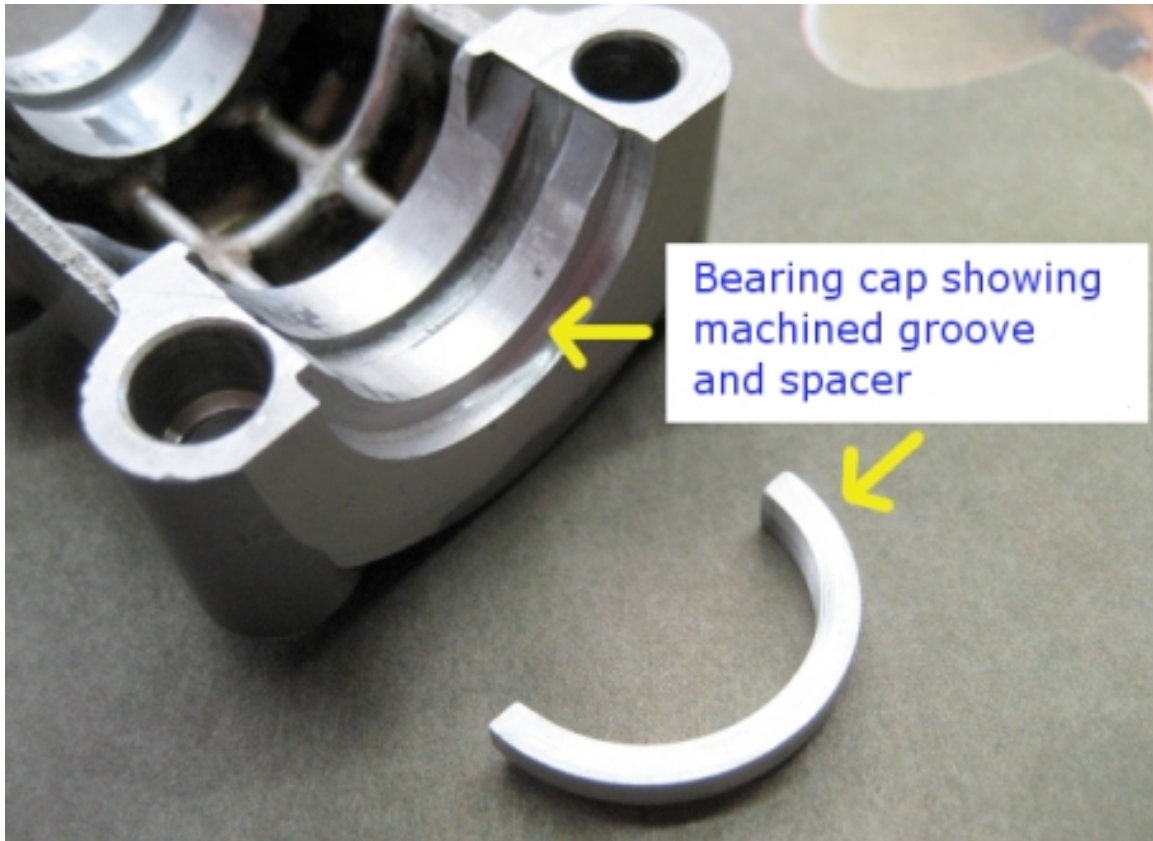
7. Check each ring for width with a vernier.
8. Clearance can now be gained by laying the ring flat on a piece of 1200 grit wet and dry, and lightly rotating the ring through a figure 8 pattern. Regularly recheck the width with the vernier until the correct size is attained.

9. Mark each ring with a centerline and hand cut each one slightly off center. This will produce an oversized half-moon that when fitted to its cap, will protrude just below the cap's mating surface.
